D93-2, D398R
or R93-2

Troubleshooting Leaking Tip-Toe Bathtub Drains

D3322, D3323, D398R, D93, R931K, R93-2, etc.

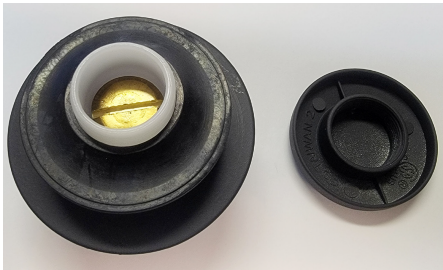
Remove Cap from drain or the cartridge from the drain body

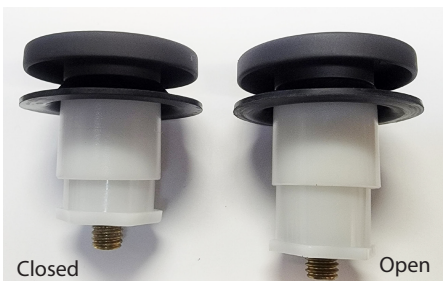
Fully Open the drain and remove the Cover Cap

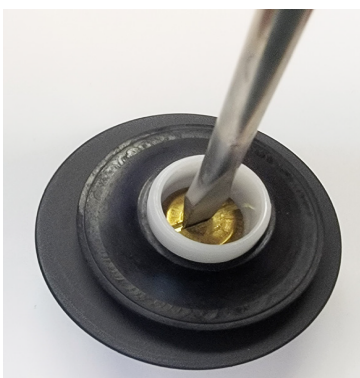
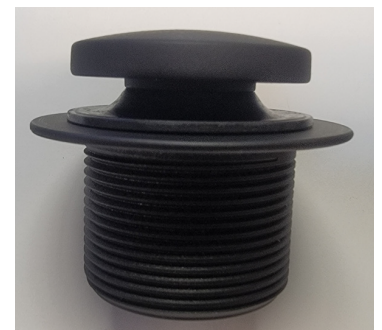
Tighten Screw with Screw driver and reinstall drain and cover. It can also help to place silicone seal onto the washer surface to keep it moist,
