# 300 LB IMPACT TESTING

Re: Field test of Clear View Glass Railings “Hercules Glass” guardrail panel  
AET Project #: 05-20608

Re: Code Requirements & Static Test of Clear View Glass Railings “Hercules Glass” guardrail panel  
AET Project #: 05-20608

# STRUCTURAL ASSESSMENT FOR NORTH CAROLINA CODE OFFICIALS

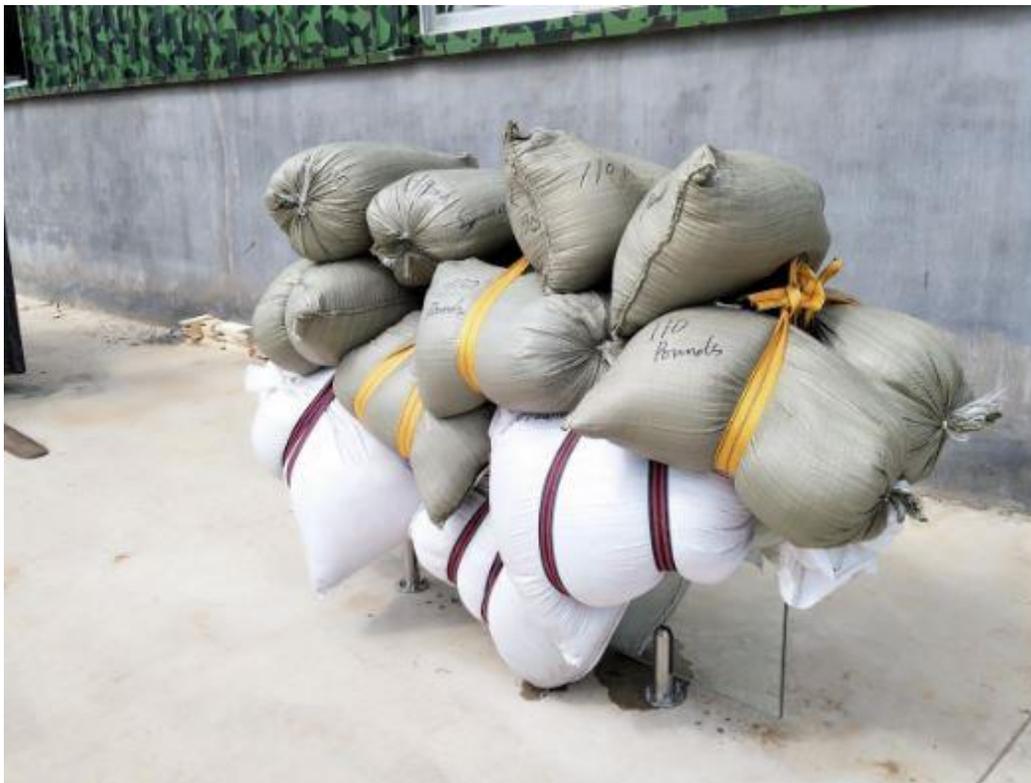
**Photo 1: Panel loaded vertically with 2,520 pounds.**

Testing was performed on the Hercules Glass panel by Clear View's glass supplier, to simulate the forces created by 800# horizontal and vertical point loads on the panel (loads are not required to be simultaneous). The vertical load test is fairly straightforward and is shown in photo 1. Note: the intent was to load the panel to failure; however, the testers ran out of sandbags at 2,520 pounds, without failure.

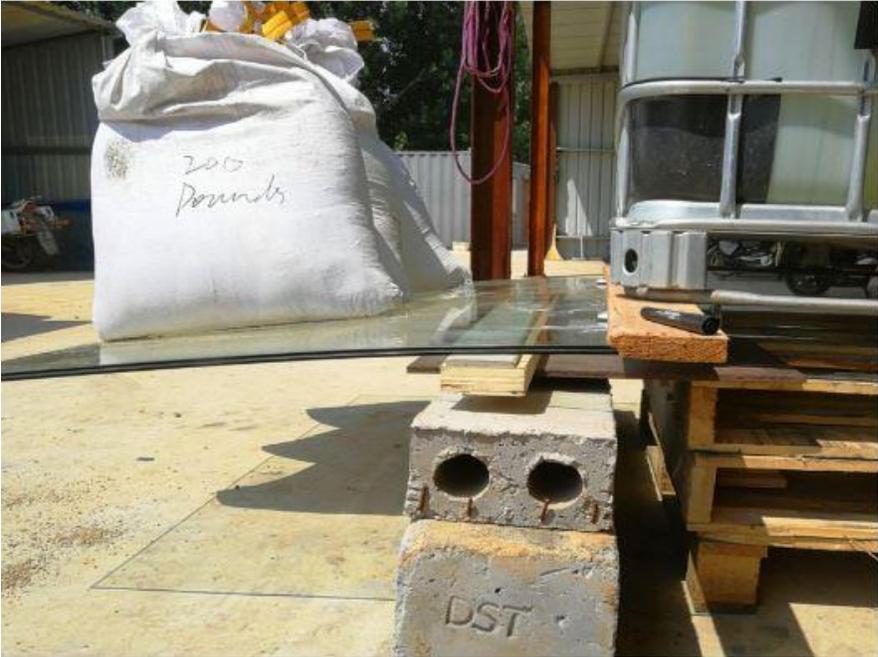
**Photo 2: Loading of panel with sandbags, simulating horizontal force**

Given the difficulty of pushing an 800# load horizontally against the panel, a test rig was set up that supports the panel on its side and places sandbags vertically on the panel. The panel is supported 28" from the top of panel (creating a 28" cantilever), with a heavy counterweight holding down the bottom of the panel mounted in its spigots. Sandbags were placed at the top edge of the panel until failure. See Diagram 1 and photo 2. The panel failed after one minute with 820 pounds loaded on its edge, which is equivalent to 547 pounds for a 42" tall panel. Using a finite element computer model, it was determined that the stresses caused by the 547 pound point load are equivalent to those caused by a 147 mph wind.

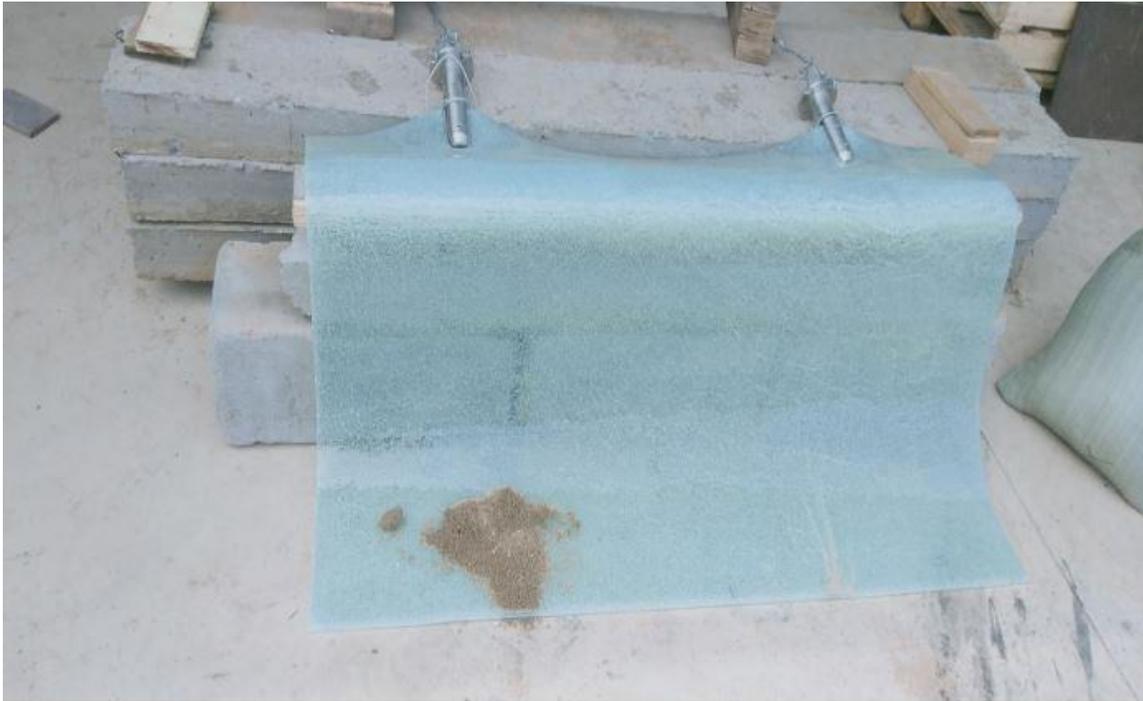
**Photo 3: Panel after failure, showing all glass intact within laminate structure.**

Due to the laminate construction of the panels (similar to a vehicle windshield), the panel broke into small pieces that were retained within the panel, preventing dangerous flying glass debris. See photo 3.

This test shows that the panel meets the intent to create a strong and safe barrier that can withstand reasonable loading (factor of safety of 2.5), and does not explode with dangerous glass shards during excessive loading.

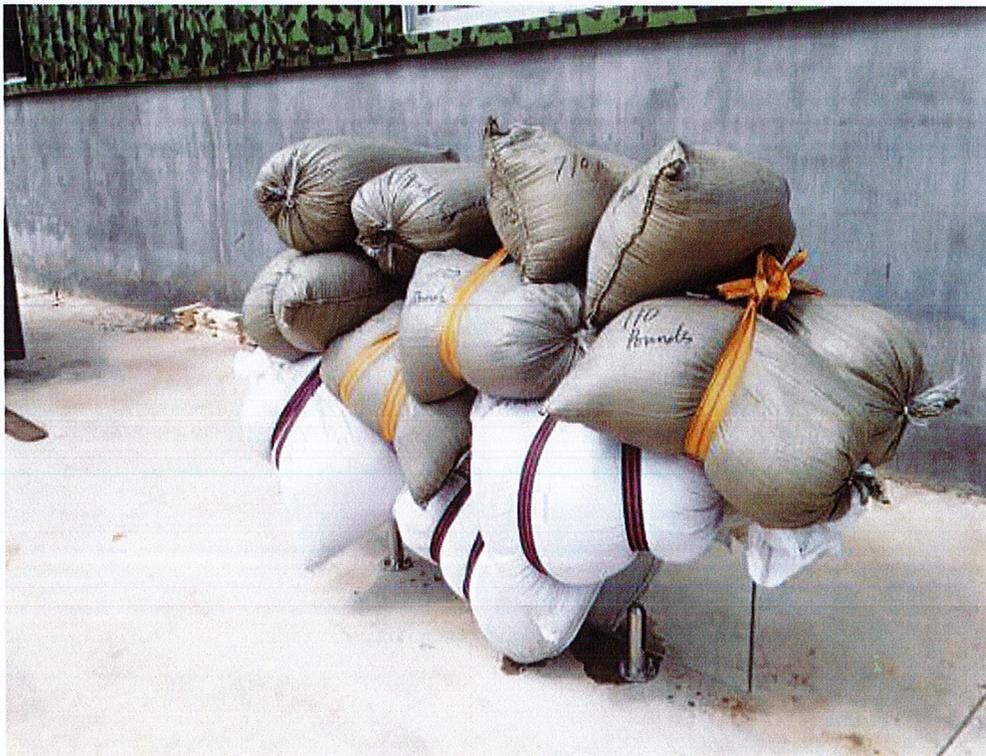
**Photo 1: Panel loaded vertically with 2,520 pounds.**

Testing was performed on the Hercules Glass panel by Clear View’s glass supplier, to simulate the forces created by 800# horizontal and vertical point loads on the panel (loads are not required to be simultaneous). The vertical load test is fairly straightforward and is shown in photo 1. Note: the intent was to load the panel to failure; however, the testers ran out of sandbags at 2,520 pounds, without failure.

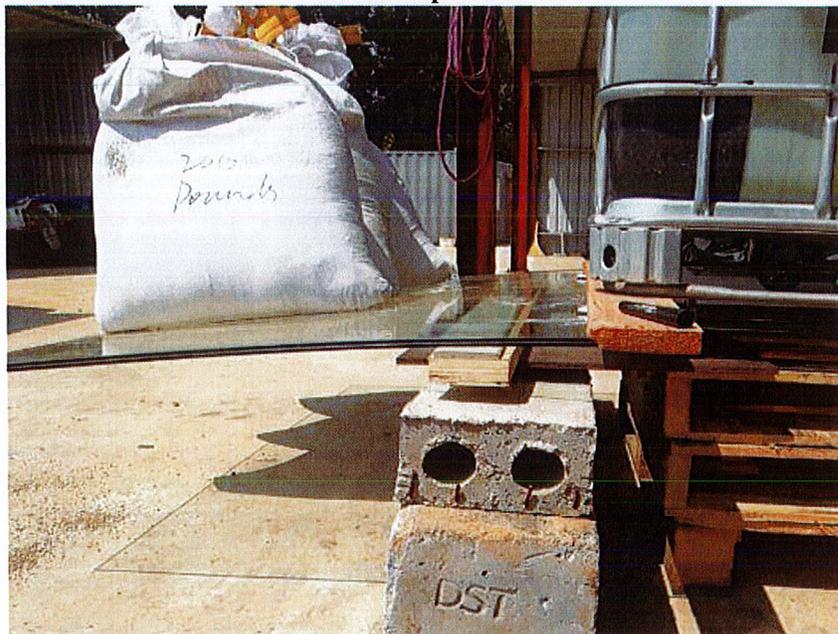
**Photo 2: Loading of panel with sandbags, simulating horizontal force**

Given the difficulty of pushing an 800# load horizontally against the panel, a test rig was set up that supports the panel on its side and places sandbags vertically on the panel. The panel is supported 28” from the top of panel (creating a 28” cantilever), with a heavy counterweight holding down the bottom of the panel mounted in its spigots. Sandbags were placed at the top edge of the panel until failure. See Diagram 1 and photo 2. The panel failed after one minute with 820 pounds loaded on its edge, which is equivalent to 547 pounds for a 42” tall panel. Using a finite element computer model, it was determined that the stresses caused by the 547 pound point load are equivalent to those caused by a 147 mph wind.

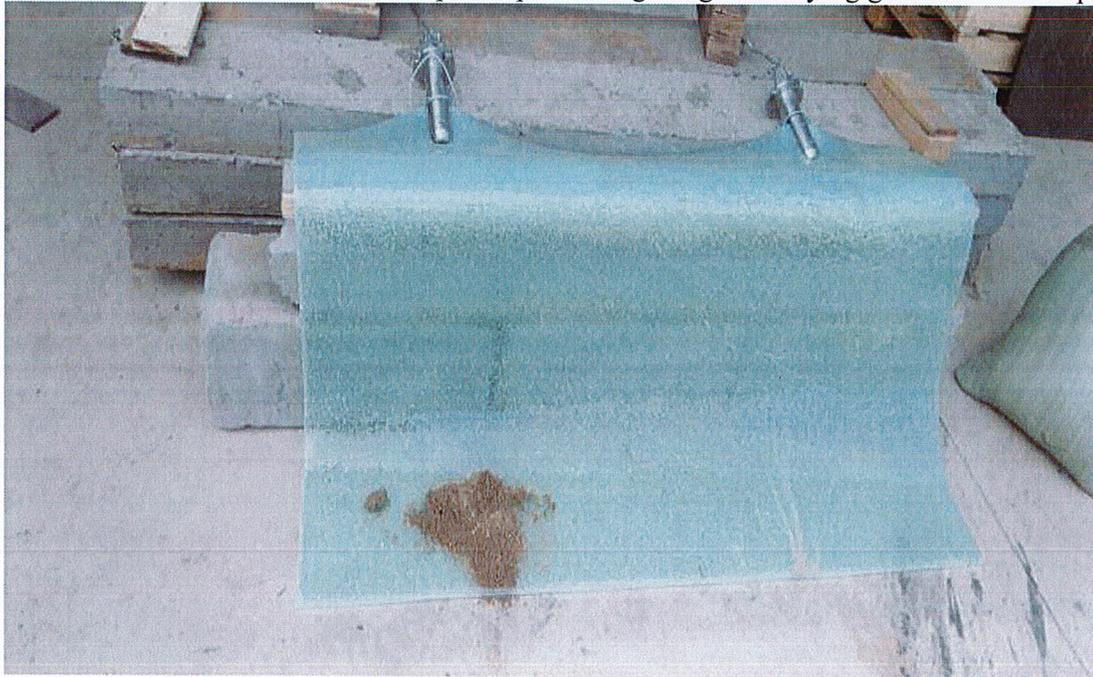
**Photo 3: Panel after failure, showing all glass intact within laminate structure.**

Due to the laminate construction of the panels (similar to a vehicle windshield), the panel broke into small pieces that were retained within the panel, preventing dangerous flying glass debris. See photo 3.

This test shows that the panel meets the intent to create a strong and safe barrier that can withstand reasonable loading (factor of safety of 2.5), and does not explode with dangerous glass shards during excessive loading.

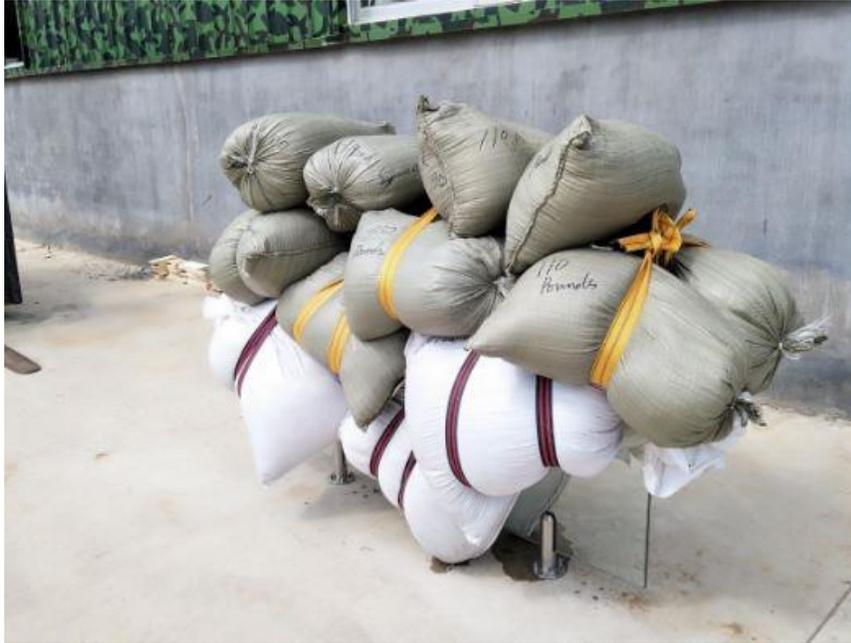
Photo 1: Panel loaded vertically with 2,520 pounds.

Testing was performed on the Hercules Glass panel by Clear View’s glass supplier, to simulate the forces created by 800# horizontal and vertical point loads on the panel (loads are not required to be simultaneous). The vertical load test is straightforward and is shown in photo 1. Note: the intent was to load the panel to failure; however, the testers ran out of sandbags at 2,520 pounds, without failure. Given the difficulty of pushing an 800# load horizontally against the panel, a test rig was set up that supports the panel on its side and places sandbags vertically on the panel. The panel is supported 28” from the top of panel (creating a 28” cantilever), with a heavy counterweight holding down the bottom of the panel mounted in its spigots. Sandbags were placed at the top edge of the panel until failure. See Diagram 1 and photo 2. The panel failed after one minute with 820 pounds loaded on its edge, which is equivalent to 547 pounds for a 42” tall panel. Due to the laminate construction of the panels (similar to a vehicle windshield), the panel broke into small pieces that were retained within the panel, preventing

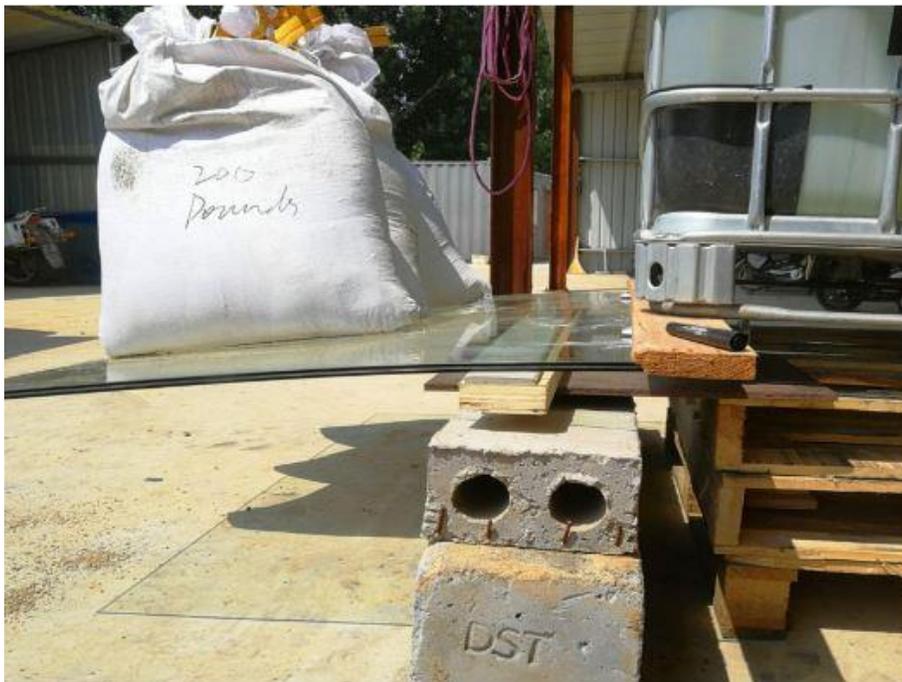
Photo 2: Loading of panel with sandbags, simulating horizontal force

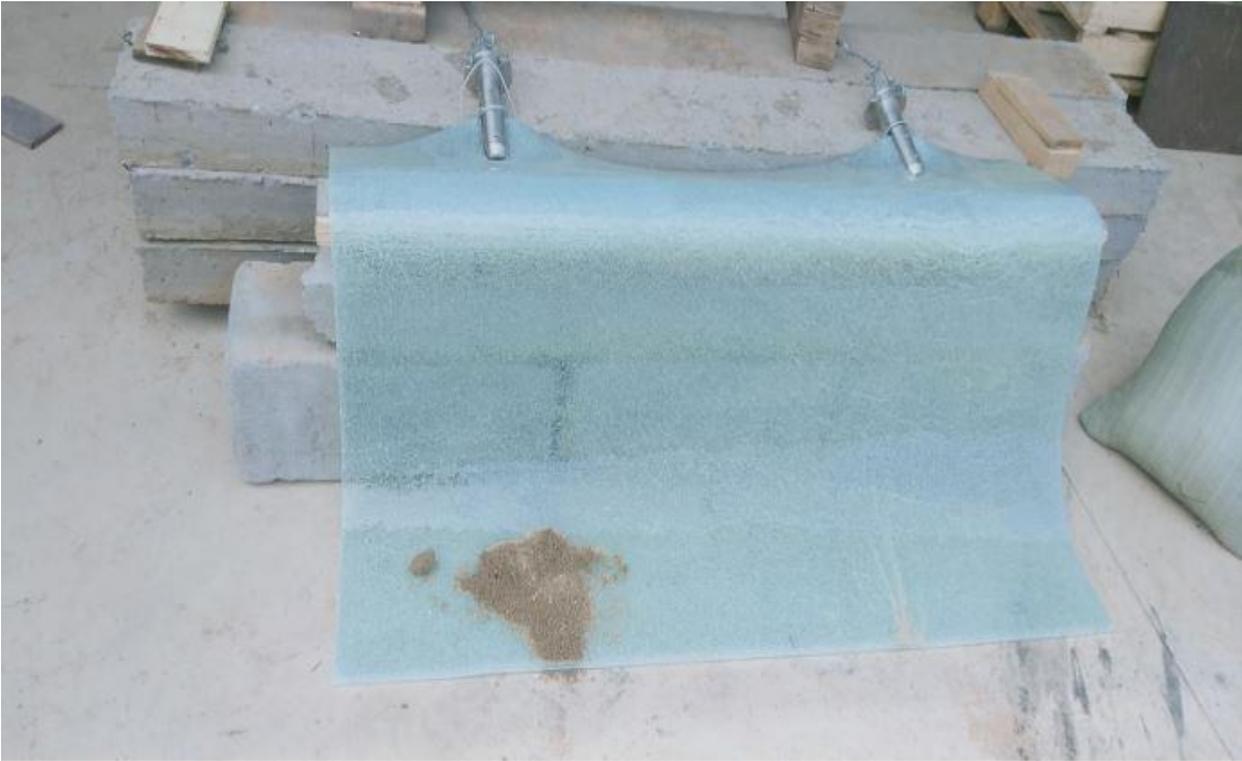
**Photo 3: Panel after failure, showing all glass intact within laminate structure.**

dangerous flying glass debris. See photo 3. This test shows that the panel meets the intent to create a strong and safe barrier that can withstand reasonable loading (factor of safety of 2.5), and does not explode with dangerous glass shards during excessive loading.

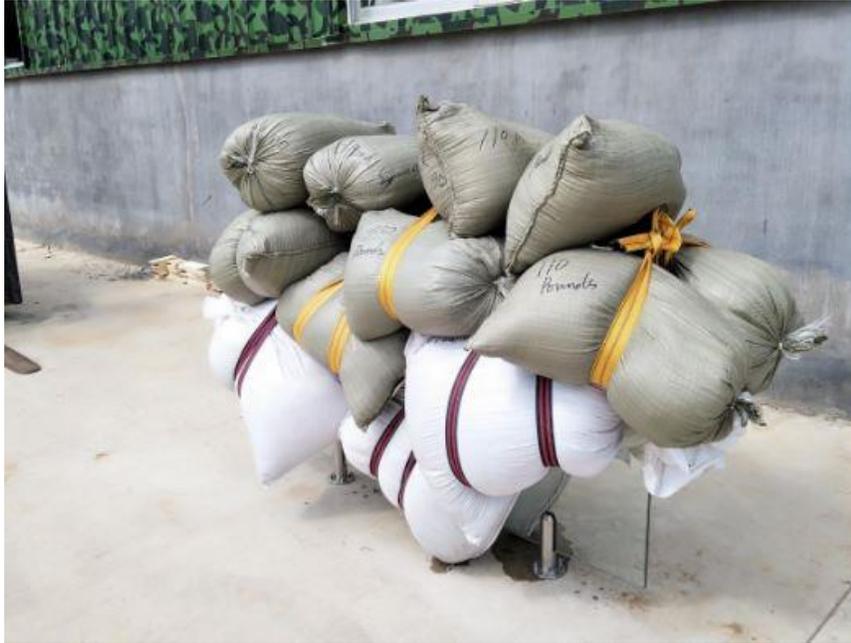
Photo 1: Panel loaded vertically with 2,520 pounds.

Testing was performed on the Hercules Glass panel by Clear View’s glass supplier, to simulate the forces created by 800# horizontal and vertical point loads on the panel (loads are not required to be simultaneous). The vertical load test is straightforward and is shown in photo 1. Note: the intent was to load the panel to failure; however, the testers ran out of sandbags at 2,520 pounds, without failure. Given the difficulty of pushing an 800# load horizontally against the panel, a test rig was set up that supports the panel on its side and places sandbags vertically on the panel. The panel is supported 28” from the top of panel (creating a 28” cantilever), with a heavy counterweight holding down the bottom of the panel mounted in its spigots. Sandbags were placed at the top edge of the panel until failure. See Diagram 1 and photo 2. The panel failed after one minute with 820 pounds loaded on its edge, which is equivalent to 547 pounds for a 42” tall panel. Due to the laminate construction of the panels (similar to a vehicle windshield), the panel broke into small pieces that were retained within the panel, preventing

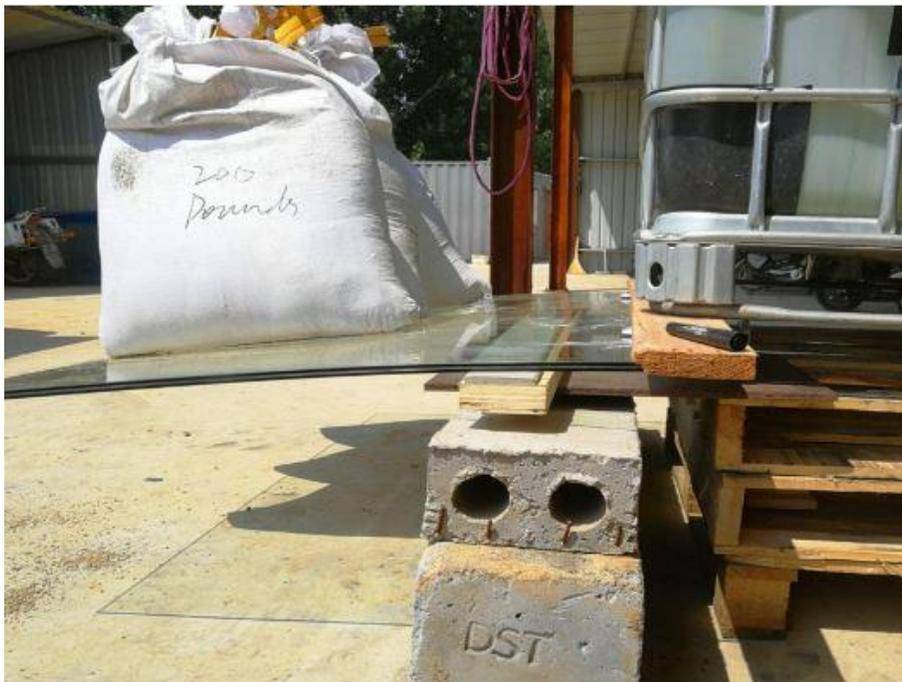
Photo 2: Loading of panel with sandbags, simulating horizontal force

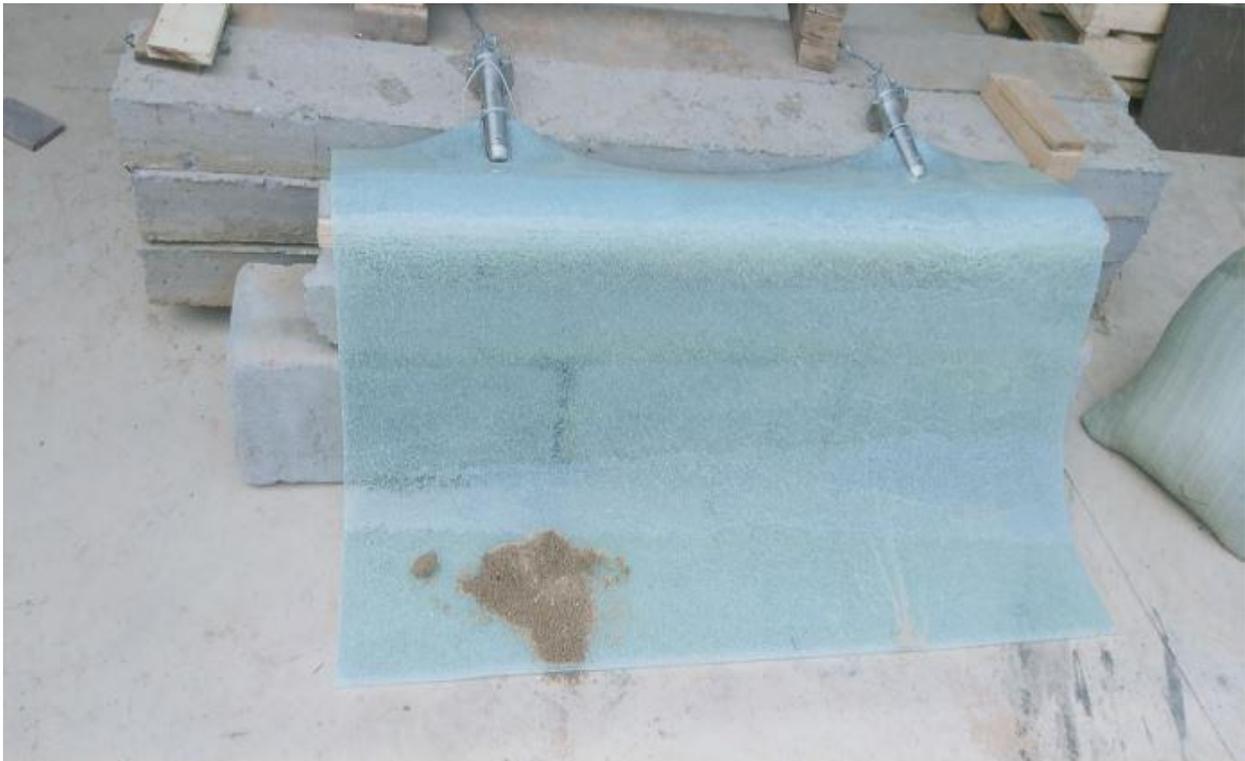
**Photo 3: Panel after failure, showing all glass intact within laminate structure.**

dangerous flying glass debris. See photo 3. This test shows that the panel meets the intent to create a strong and safe barrier that can withstand reasonable loading (factor of safety of 2.5), and does not explode with dangerous glass shards during excessive loading.

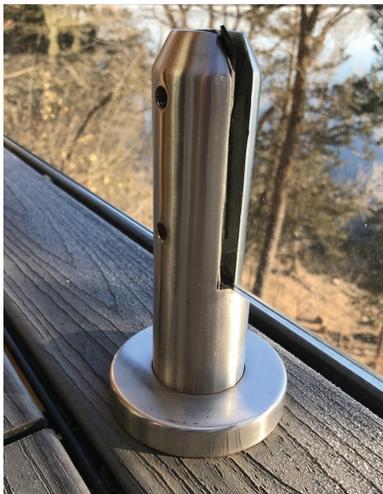
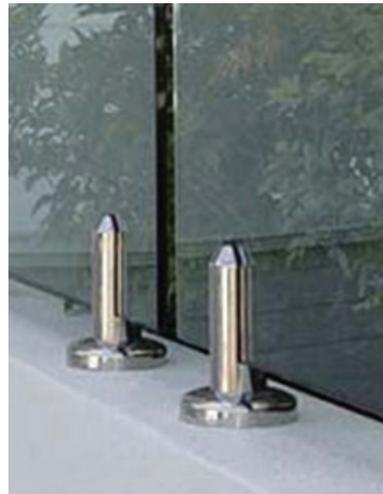
# INSTALLATION WITH THREE SPIGOTS

<b>Part Number</b>	CVGR 316 SSOD48-180 Satin Finish
<b>Product Name</b>	Round Deck Mount Spigot
<b>Spigot Size</b>	1.9" diameter x 7.1" tall
<b>Spigot Weight</b>	5.5 lbs.
<b>Glass Thickness/ Dimensions/Weight (per panel)</b>	13mm/ 60" width x 39.37" height/98.5 lbs.
<b>Accessories Included</b>	Base Cover, Rubber Gasket

The hold down force for each spigot is 2,500 lbs. We suggest using 3/8" diameter x 3.5" A354 structural bolts as they have sufficient capacity to resist this force. Use with flat washer to fasten spigots to wood deck. A354 structural bolts and washer should be cadmium plated or stainless steel so they do not rust.
